NO. PO6
DECEMBER 1956

Power
Division

DESCRIPTION OF REPAIRS TO SPILLWAY PIERS OF KEOKUK DAM

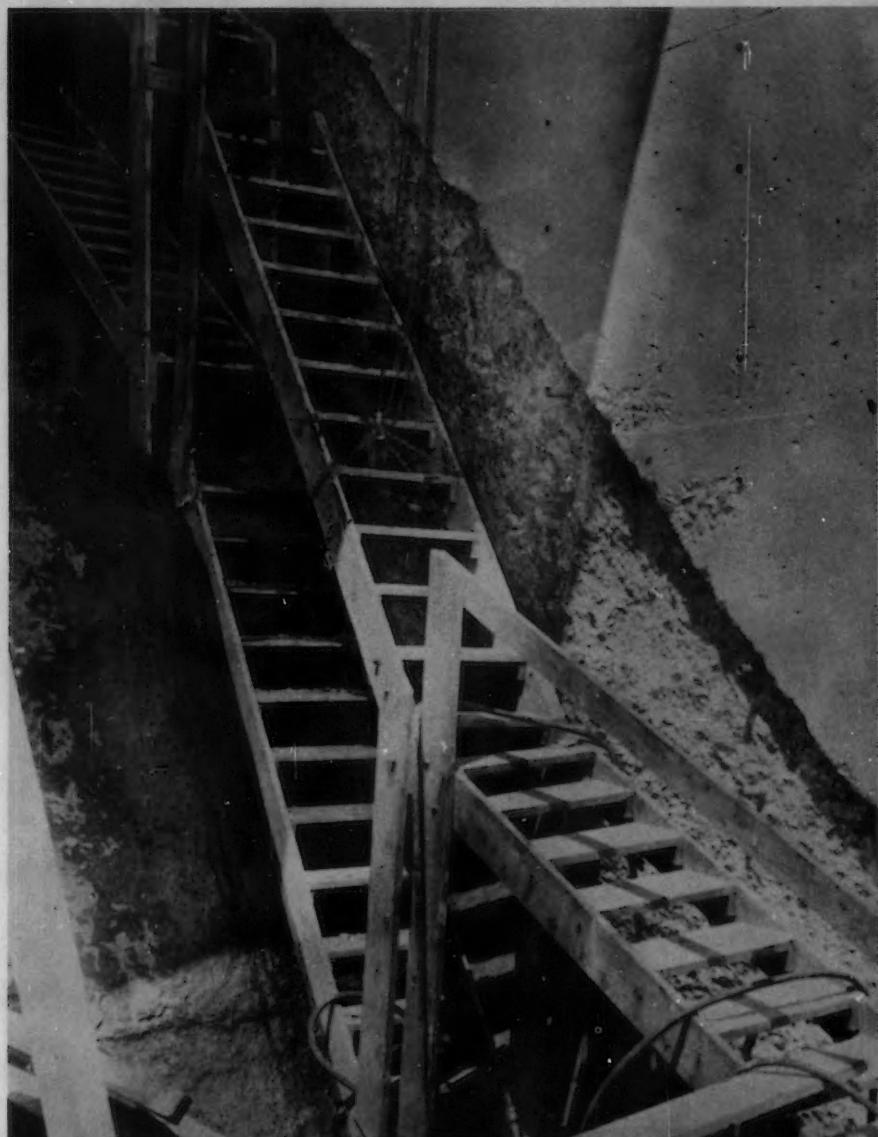
FIGURE 5 SHOWING CONCRETE REMOVED FROM SIDE OF PIER NO. 7.

On the sides of the piers a minimum cut of 6" is specified. On the 75 piers repaired to date, the 6" cut has been ample to reach sound concrete at the top of the deteriorated area. The maximum cut required thus far to reach sound concrete has been 12".

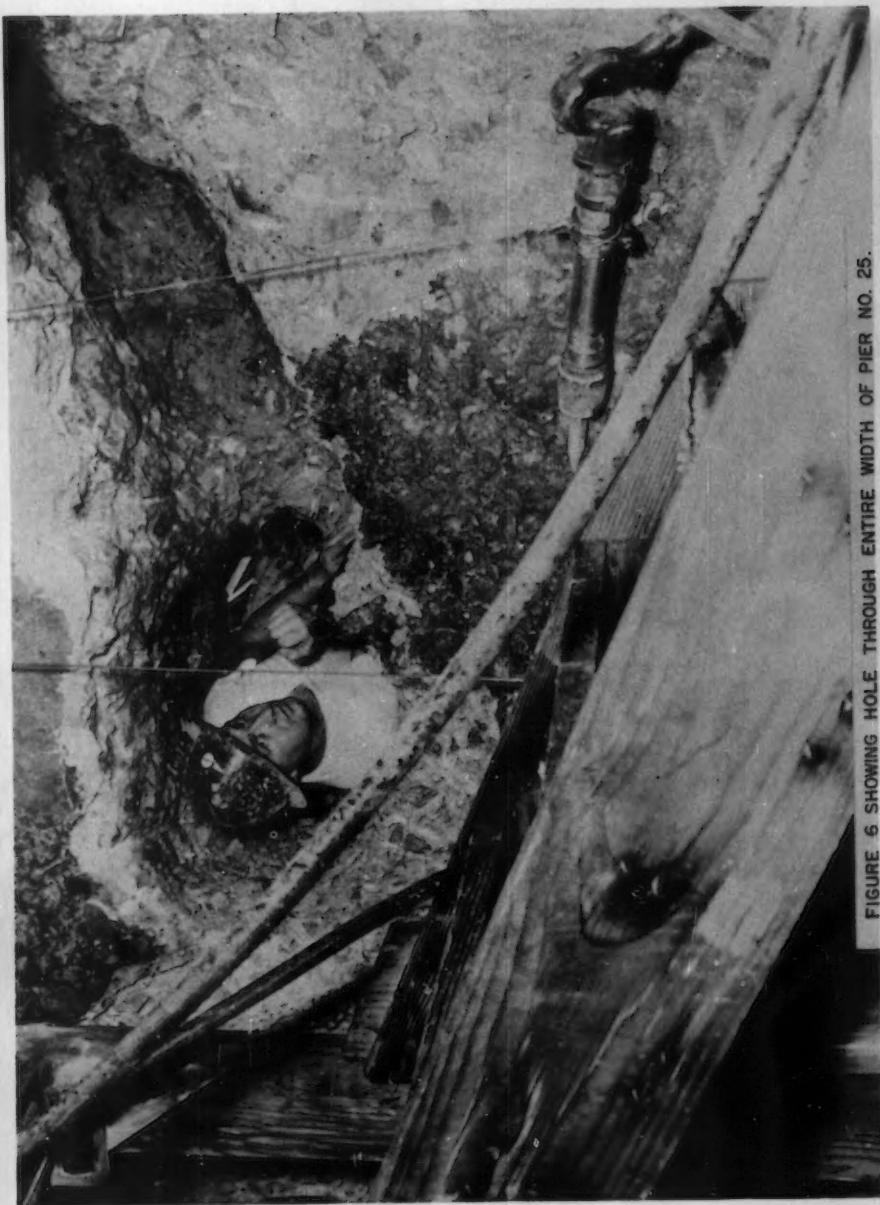
FIGURE 6 SHOWING HOLE THROUGH ENTIRE WIDTH OF PIER NO. 25.

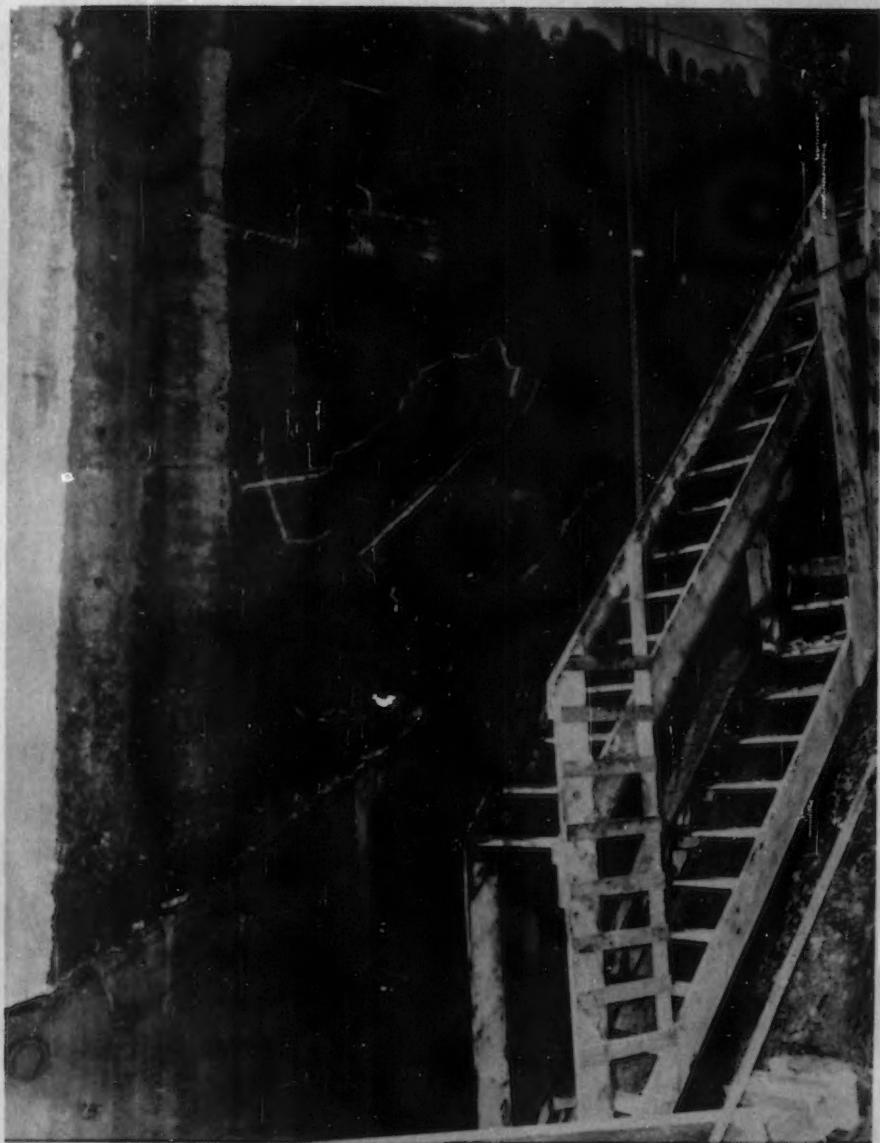
FIGURE 8 SHOWING CONCRETE REPAIR IN PLACE WITH DRY PACK JOINT EXPOSED.

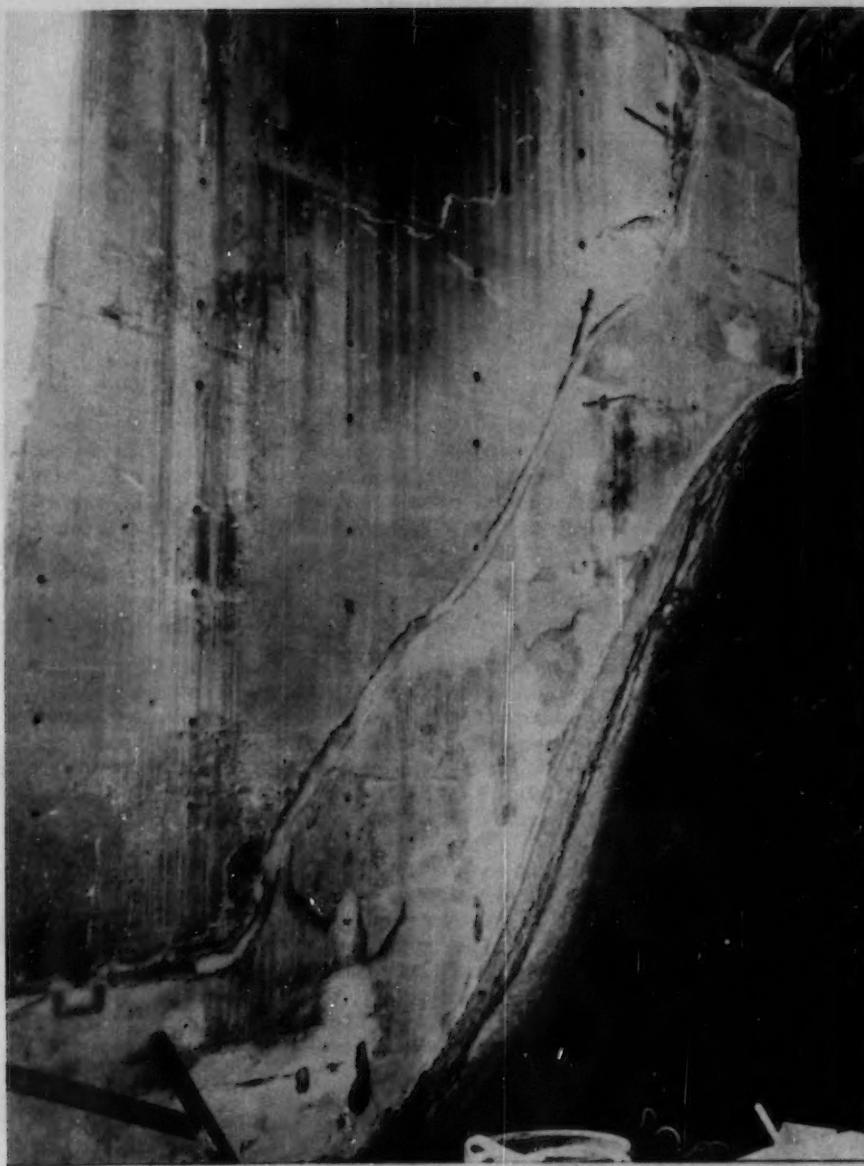
FIGURE 9 SHOWING COMPLETED REPAIR WITH DRY PACK JOINT IN PLACE
